AFRPL-TR-70-43

**LONG-TERM STORABILITY
OF
PROPELLANT TANKAGE AND COMPONENTS
INTERIM REPORT #1**

R. B. MEARS, 1st LIEUTENANT, USAF

MAY 1970

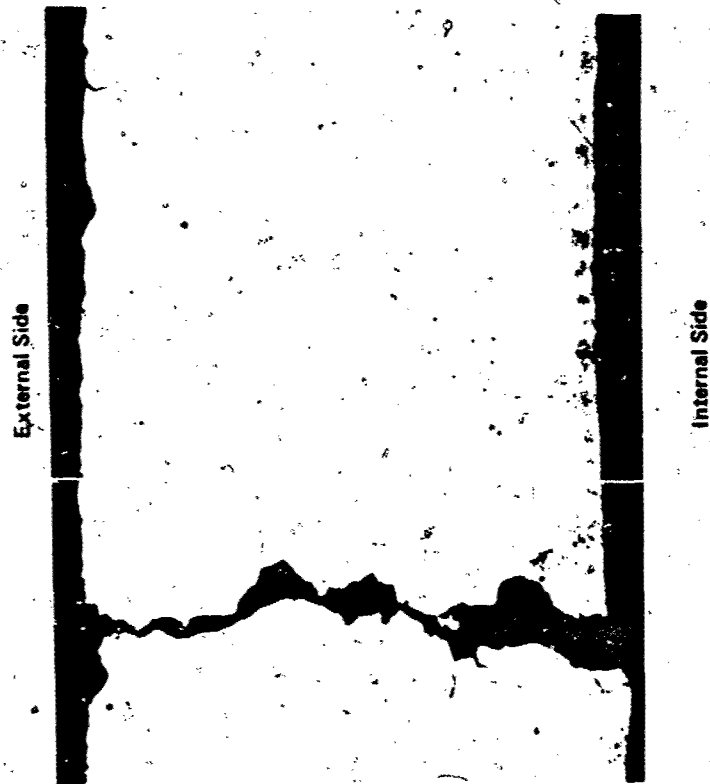
Figure 5. 301 SS (Unetched)
100X

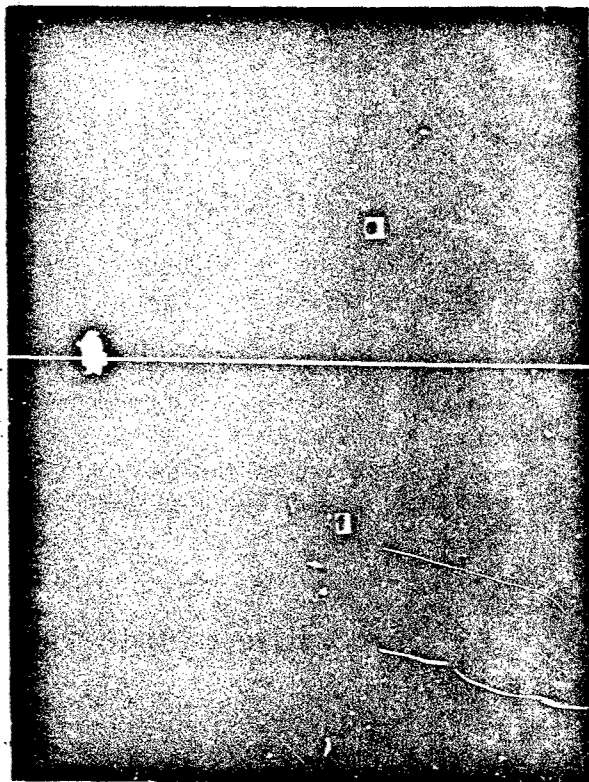
Figure 5. Holes in tank wall as seen
from outside. 10X

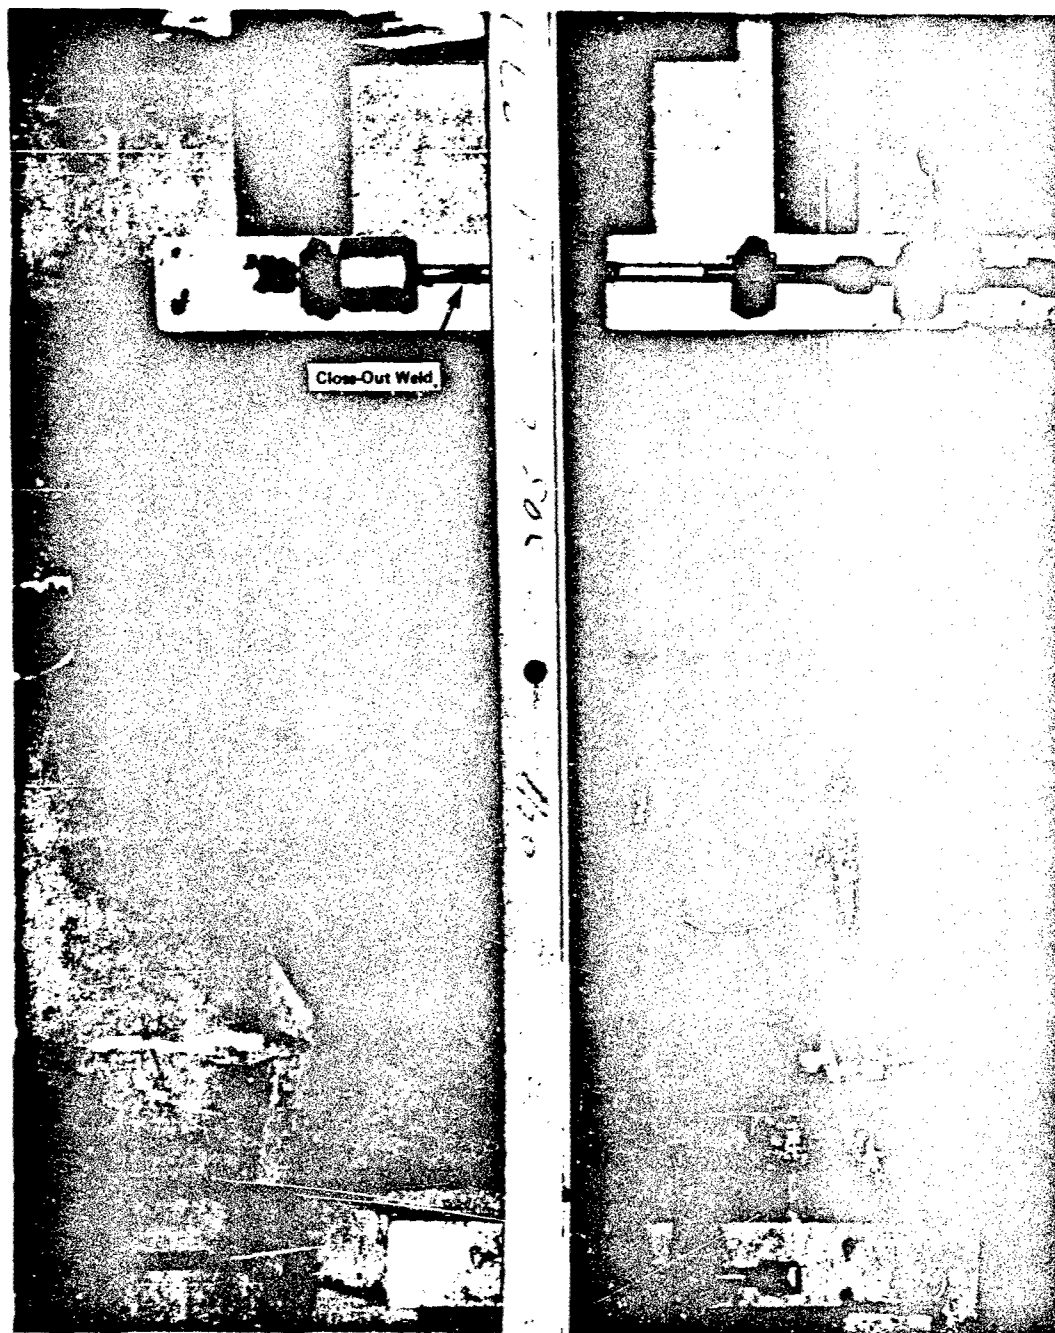
Figure 7.

B. Close-out weld: The close-out weld was oriented such that it faced downward onto the top of the tank. (Fig. 7). Corrosion of the close-out weld was localized. In figs. 10, 11, & 15 a "plug" of weld material appears missing. Two tongue-like protrusions can be seen directed toward the inside of the tube. The weld material could have been locally corroded away after a leak had developed in the weld region. The origin of this hypothetical leak is unknown. However, it is felt that the most probable cause was by pitting corrosion at a crack or crevice in the weld area of the interior surface of the tube. (Fig. 12)

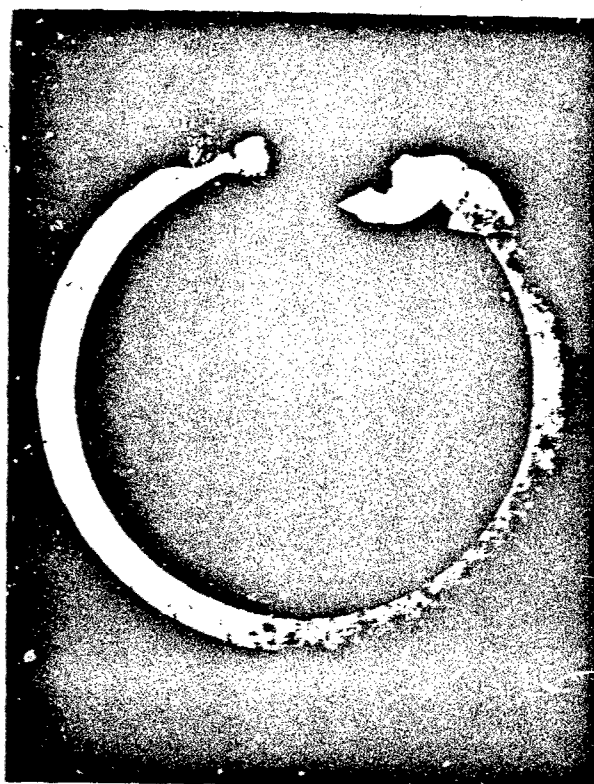
An entire cross-section of the tube at the hole of the close-out weld is shown in Fig. 11.

Figure II. Cross-section of tube at
close-out weld (Etched) 6X

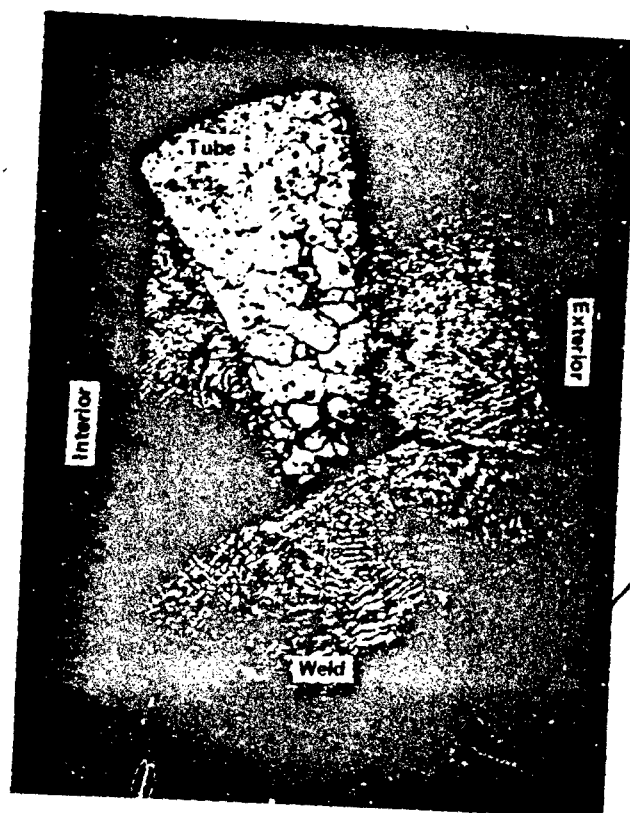
The grain structure of the 6061-T6 tube is shown in Fig. 14. The grain structures of 6061 and 4043 in the close-out weld region are shown in Figs. 12 and 13. Note the accentuated laboratory etching of grain boundaries in the 6061-T6 tube near the weld. Diffusion to the grain boundaries probably occurred during welding. These diffusion aggregates have thus been eaten up by the lab etchant.

Figure 12. Weld Region of close-out
showing grain structures
(Etched) 41X

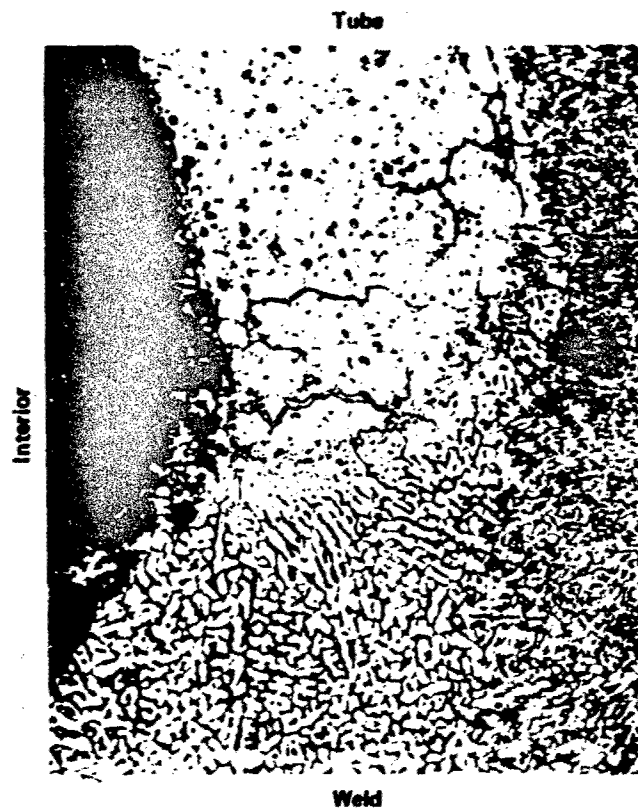
Figure 13. Weld region of close-out weld
showing grain structures
(Etched) 81X

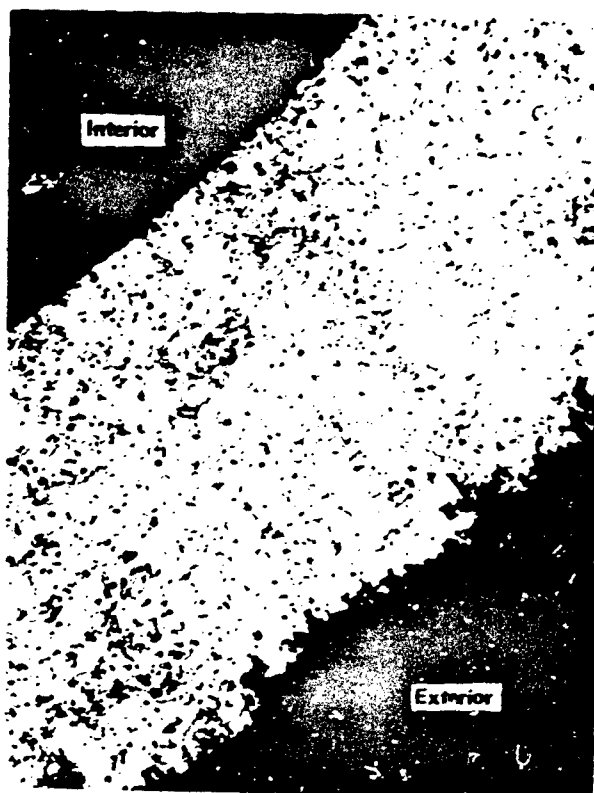
Corrosion of the exterior wall of the aluminum tubing only occurred near the hole left by the close-out weld. The interior wall of the aluminum tube was not corroded. (Fig. 14)

Figure 14. Aluminum tubing.
(Etched) 81X

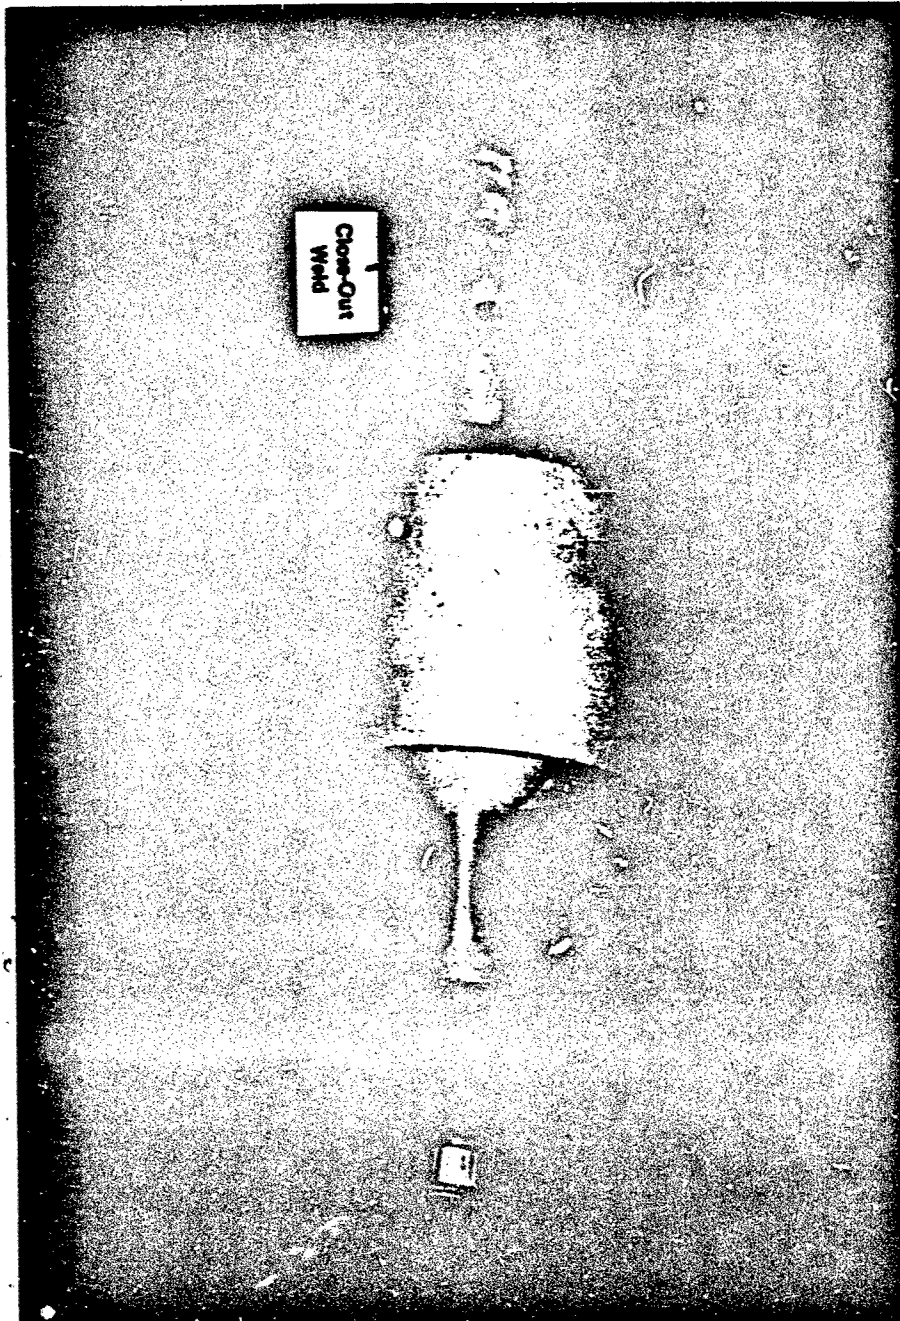
Figure 15. Burst Disc Assembly
